# **INDOOR AIR QUALITY ASSESSMENT**

**Mixer Municipal Office Building  
120 Prescott Street  
West Boylston, Massachusetts**

Prepared by:  
Massachusetts Department of Public Health  
Bureau of Environmental Health Assessment  
Emergency Response/Indoor Air Quality Program  
September 2003

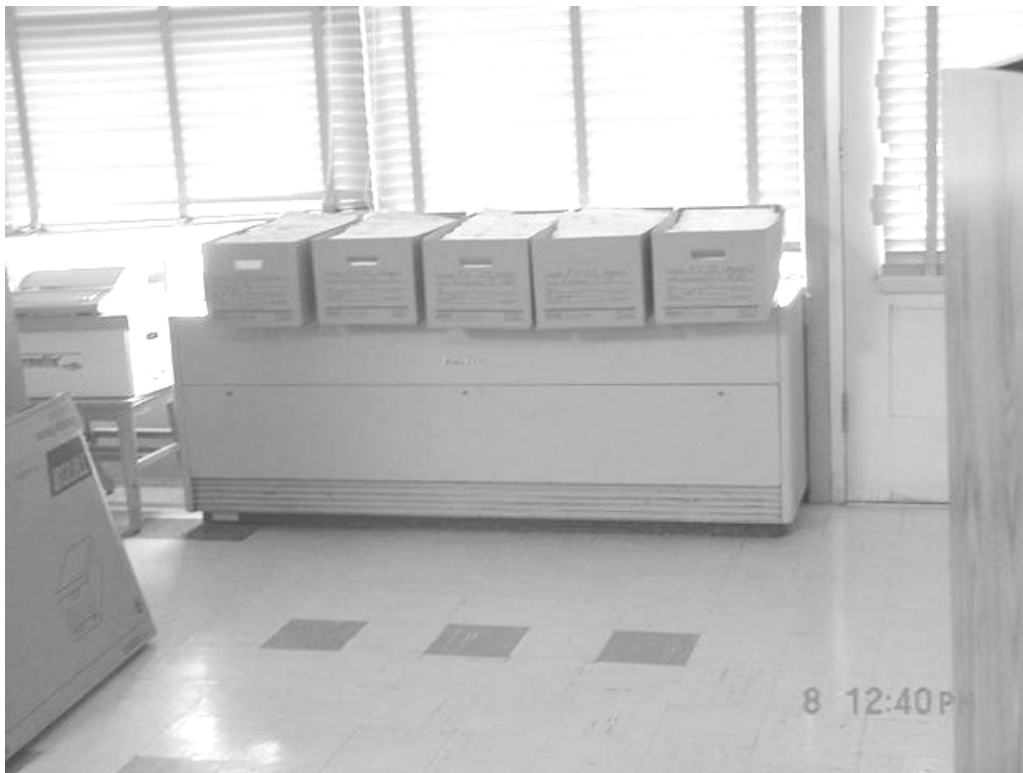
**Picture 1**

Fresh air is provided to office space by a unit ventilator (univent) system (Picture 1). A univent draws fresh air from a vent on the exterior of the building and air from the interior (called return air) through a vent in the base of the unit ([Figure 1](#)). Fresh air and return air are mixed, filtered, heated and expelled into the classroom through a fresh air diffuser located on the top of the unit. All outside air intakes for univents were sealed with sheet metal, eliminating the ability of the system to introduce fresh air (Picture 2). Univents on the east side of the building were removed and replaced with baseboard

**Typical 1950's Vintage Univent**

3. Examine the feasibility of restoring mechanical supply and exhaust ventilation. Based on the age, physical deterioration and availability of parts of the HVAC system, the BEHA strongly recommends that the HVAC engineering firm fully evaluate the ventilation system for proper operation, and/or repair/replacement considerations.

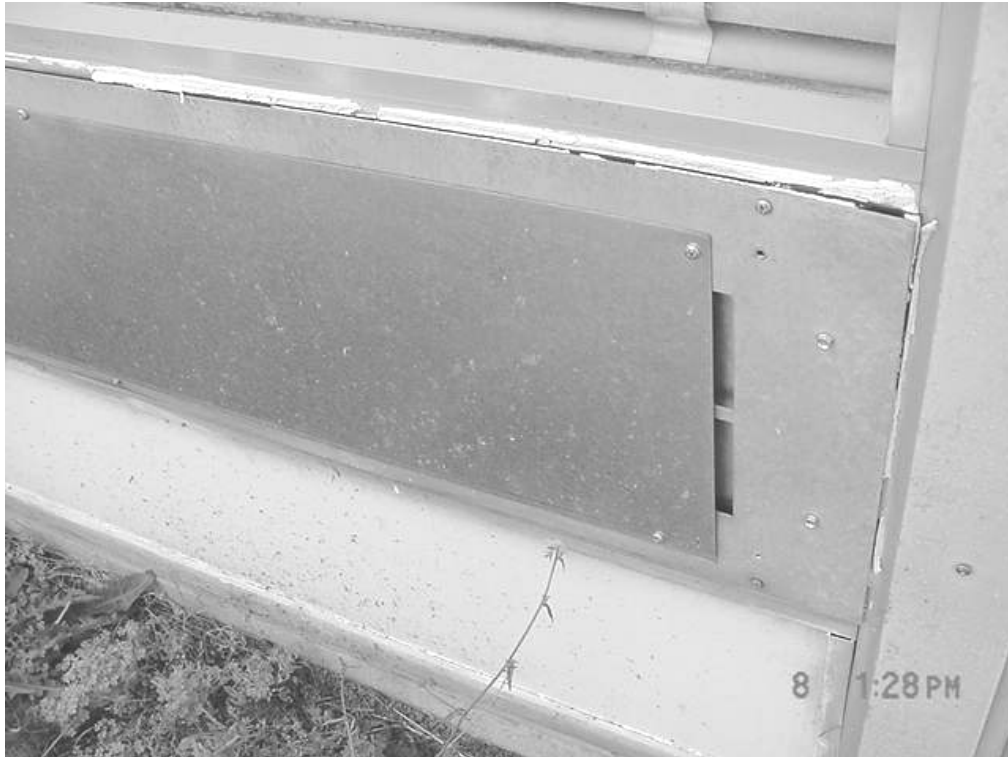
**Picture 2**

**Univent Air Intake Sealed With Sheet Metal on Exterior of Building**

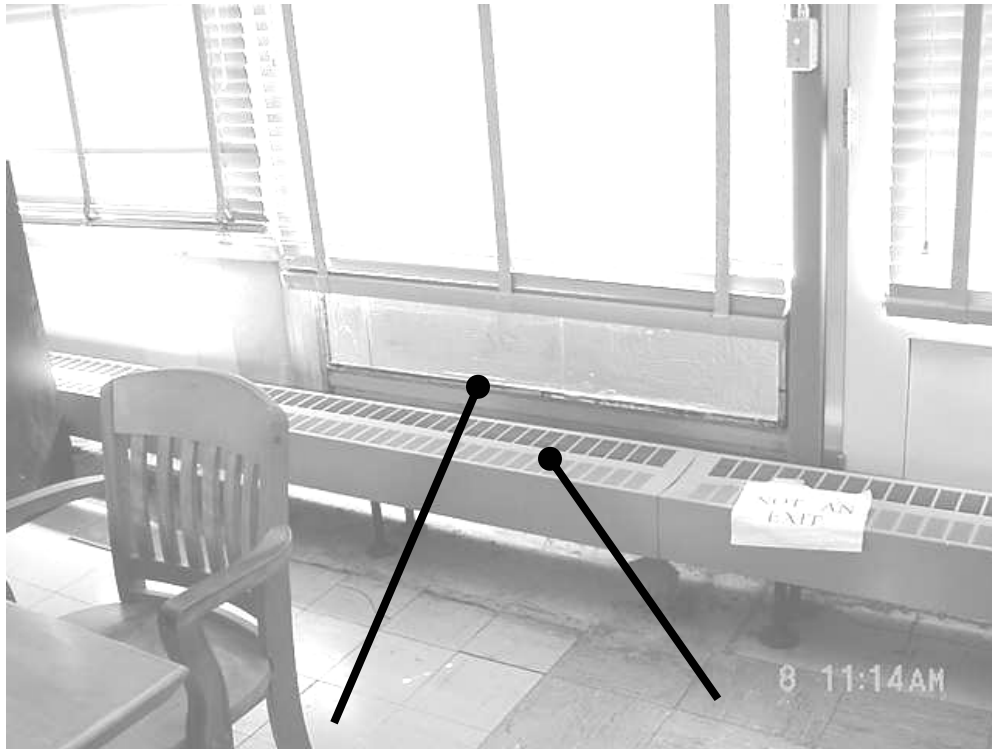
**Picture 3**

radiant heat (Picture 3). A few of the remaining univents were operating during the assessment, however, with air intakes sealed, univents were only recirculating office air.

**Univent Removed and Replaced With Baseboard Radiant Heat**

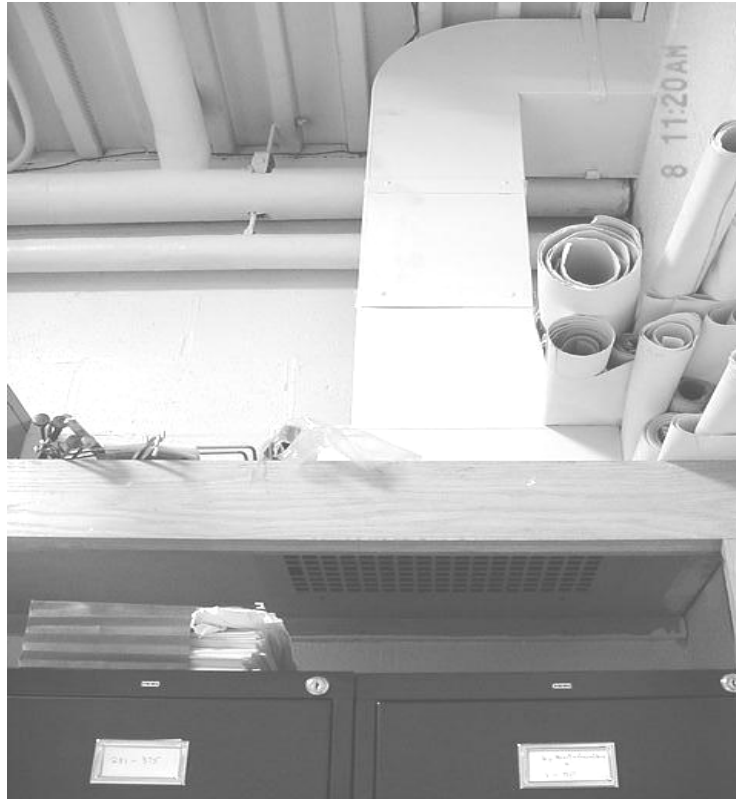
**Picture 4**

Exhaust ventilation is provided by grilled, ducted vents (Picture 4) connected to rooftop motors (Picture 5). A number of the exhaust vents were obstructed with file cabinets and other stored items (Picture 6). During the assessment, no draw from exhaust vents could be detected in any occupied areas. Lack of draw can indicate rooftop motors were deactivated or not operating. BEHA staff and Mr. Barrell examined conditions on the roof and found two of fourteen exhaust motors operating. Without mechanical supply and exhaust ventilation, indoor air pollutants can build up and lead to indoor air quality/comfort complaints.

**Mechanical Ducted Exhaust Vent**

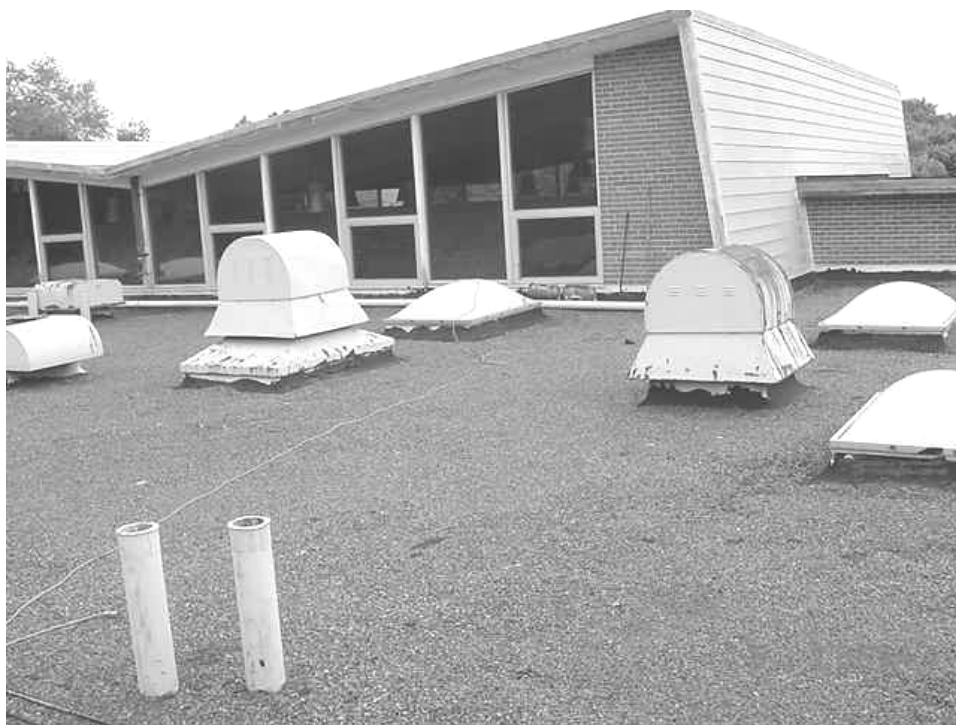
**Picture 5**

**Inactive Rooftop Exhaust Vents**

3. Inspect rooftop exhaust motors and belts for proper function. Repair and replace as necessary.
4. Once rooftop motors are reactivated, remove all blockages from exhaust vents to ensure adequate airflow.

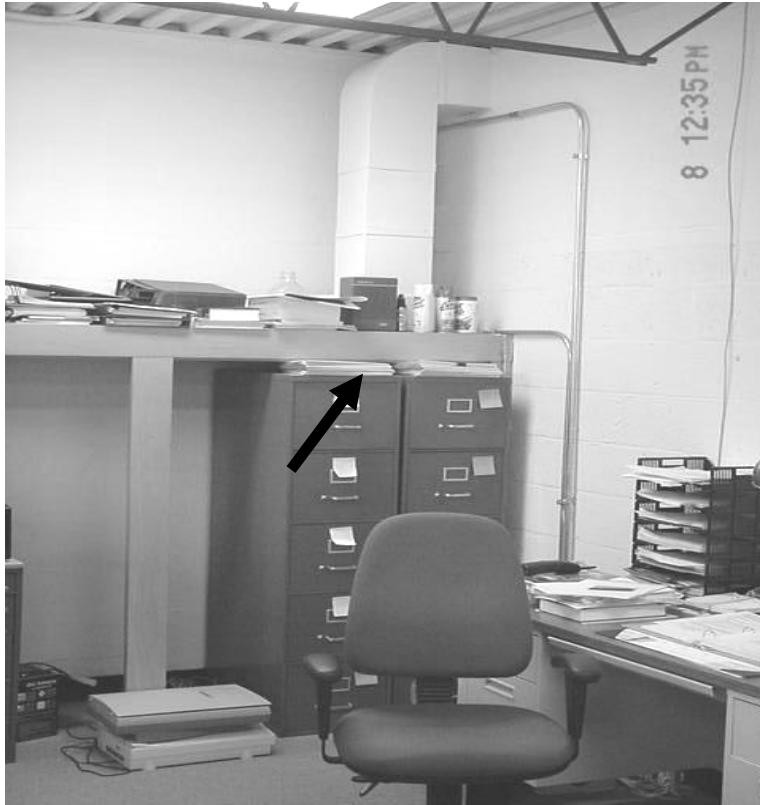
**Picture 6**

**Exhaust Vent Obstructed by File Cabinets and Files**

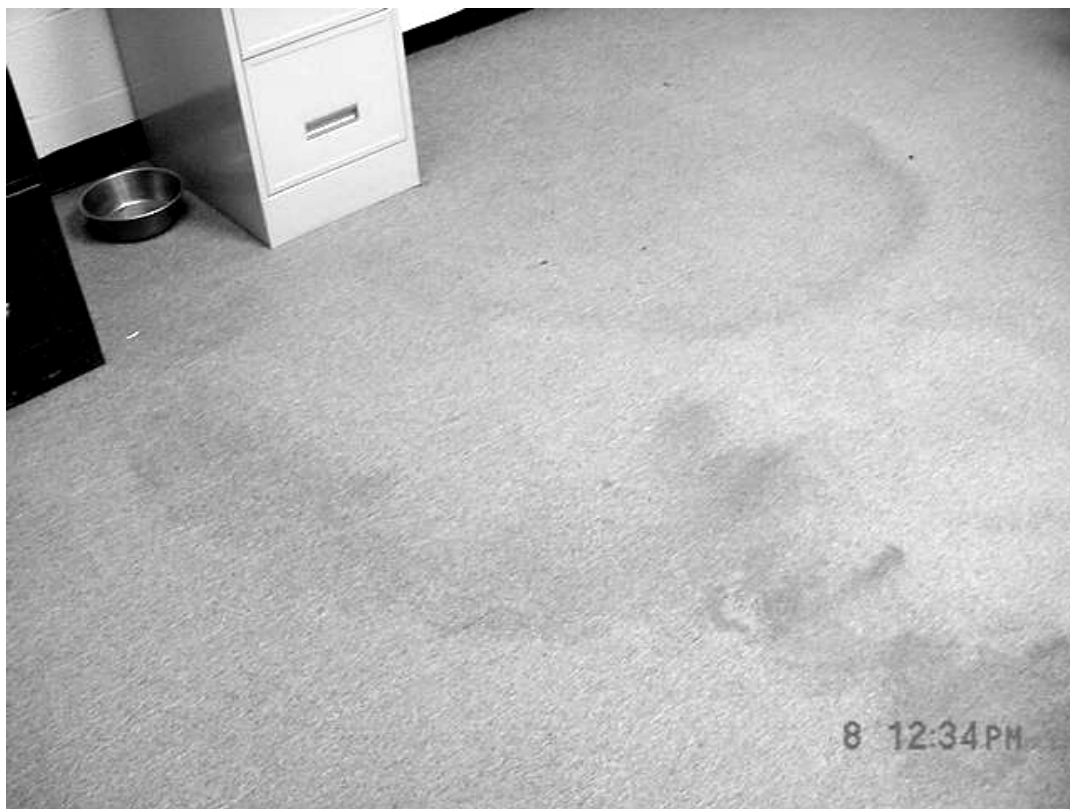
**Picture 7**

Occupants have reported that the building has a history of roof leaks. The TV room had sheets of plastic polyethylene covering up electronics equipment to protect them from water damage. Water damaged ceiling tiles, walls and carpeting were noted in a number of areas (Pictures 7 & 8). Visible mold growth was observed on corkboard in the Coast Guard room and on the wall of the storage room off the main hallway (Pictures 9 & 10). Fungal growth was observed beneath/behind wooden framed corkboard in the main entrance, which is an area that has experienced chronic water damage (Picture 11). The American Conference of Governmental Industrial Hygienists (ACGIH) recommends that porous materials (e.g. corkboard, carpeting, ceiling tiles) be dried with fans and heating within 24 hours of becoming wet (US EPA, 2001, ACGIH, 1989). If porous materials are not dried within this time frame, mold growth may occur. Water-damaged

**Water Damaged Carpeting**

1. Remove and replace any mold contaminated/water damaged materials (e.g. carpeting/padding, cork board, gypsum wallboard). This measure will remove actively growing mold colonies that may be present. Remove mold contaminated materials in a manner consistent with recommendations found in “Mold Remediation in Schools and Commercial Buildings” published by the US Environmental Protection Agency (US EPA, 2001). Copies of this document can be downloaded from the US EPA website at:[http://www.epa.gov/iaq/molds/mold\\_remediation.html](http://www.epa.gov/iaq/molds/mold_remediation.html)

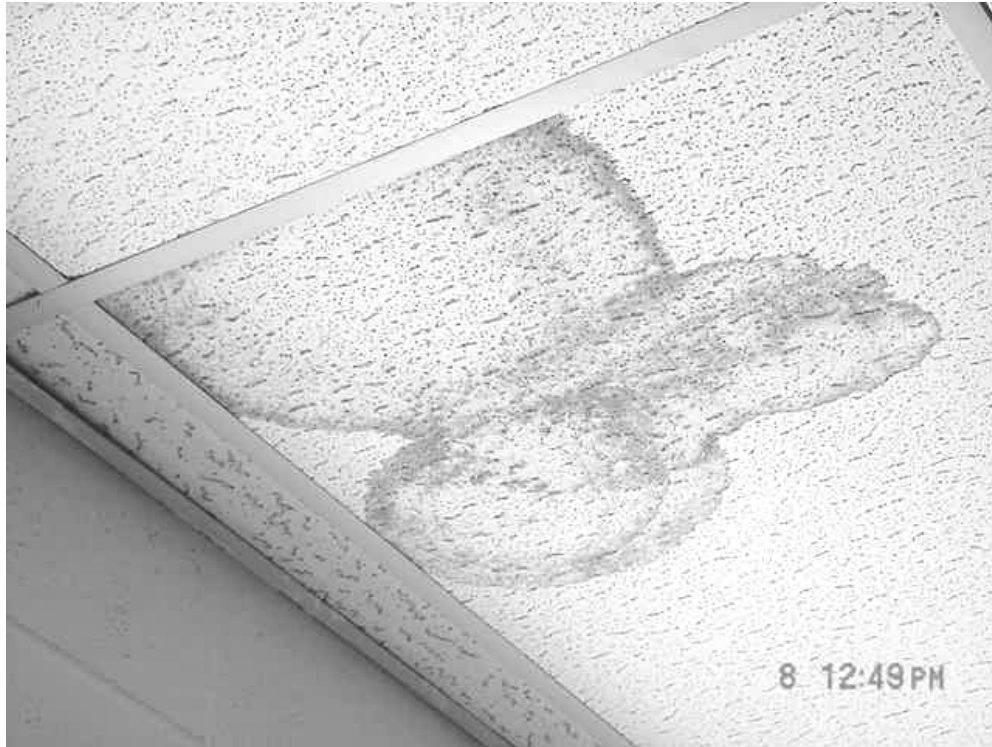
**Picture 8**

**Water Damaged Ceiling Tiles**

8. Ensure roof leaks are repaired. Once repaired replace any water-stained ceiling tiles. Disinfect areas of water leaks with an appropriate antimicrobial.

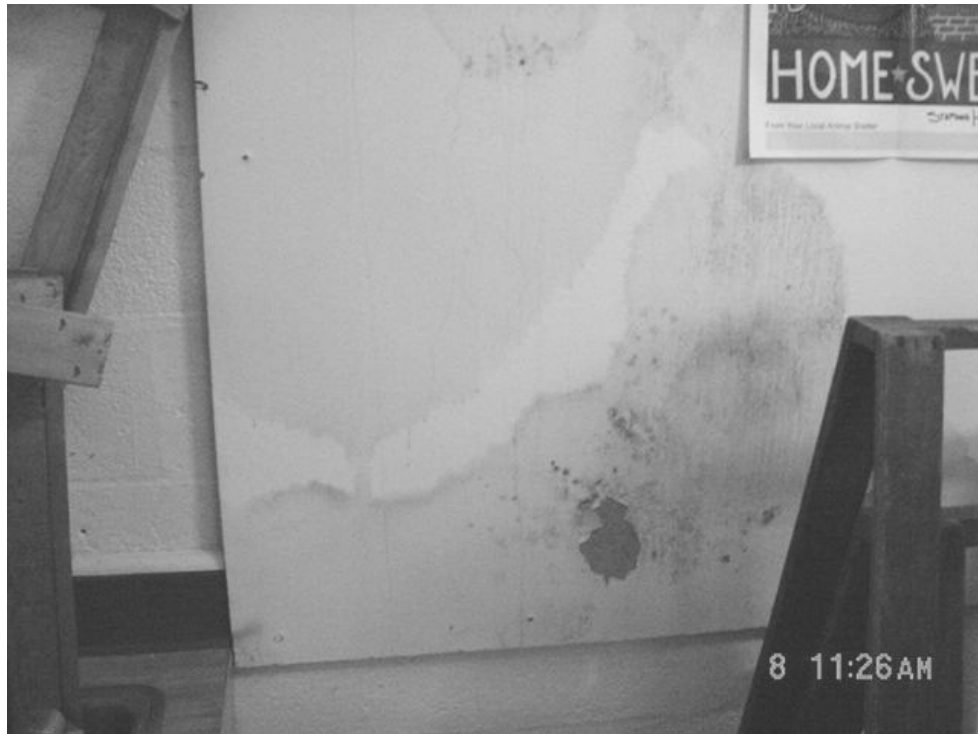
**Picture 9**

**Water Damaged/Mold Growth on Cork Board in Coast Guard Room**

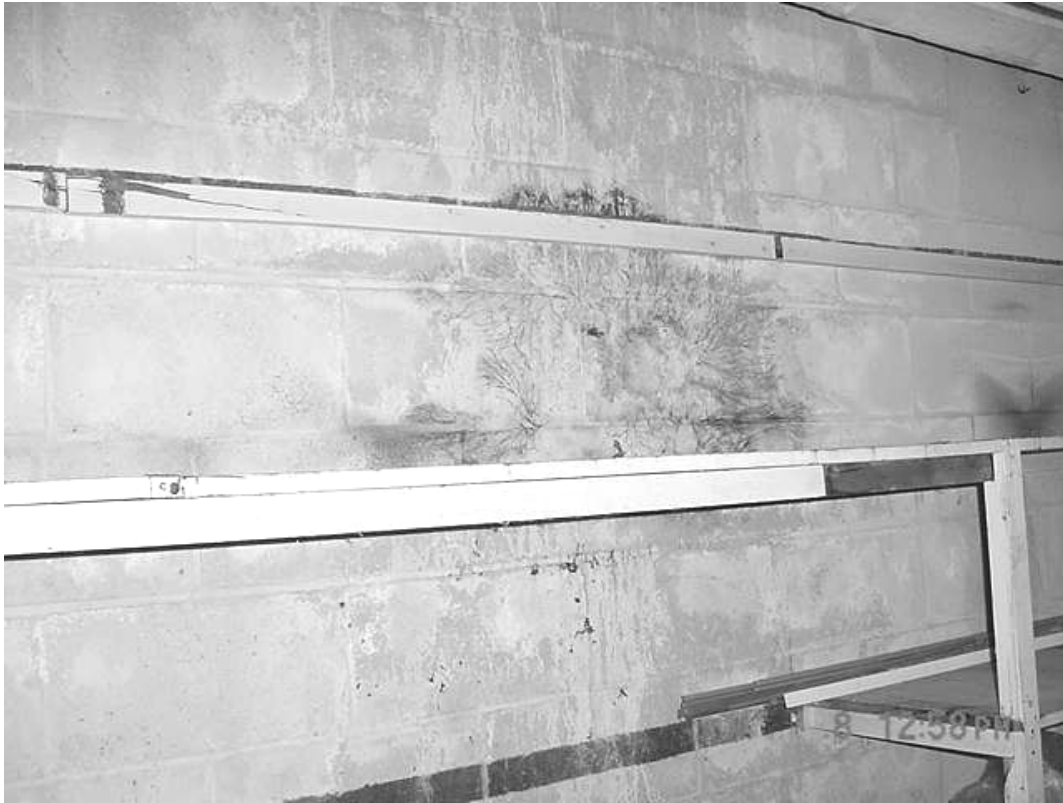
**Picture 10**

**Visible Mold Growth on Wall of Storage Room (Indicated by Dark Stains)**

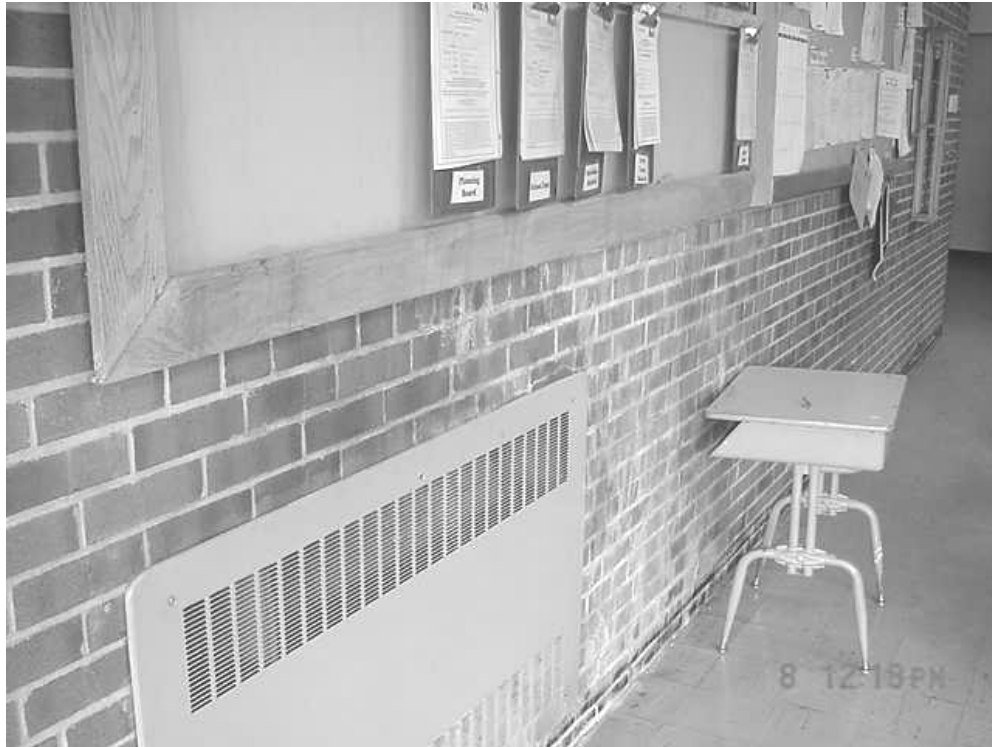
**Picture 11**

Efflorescence (i.e. mineral deposits) was noted on walls in the main entrance and in the adjacent storeroom. Efflorescence is a characteristic sign of water damage to building materials such as brick or plaster, but it is not mold growth. As moisture penetrates and works its way through mortar around brick, water-soluble compounds in bricks and mortar dissolve, creating a solution. As the solution moves to the surface of the brick or mortar, water evaporates, leaving behind white, powdery mineral deposits. Several potential sources of water penetration exist:

**Efflorescence and Water Damaged Wooden Framed Cork Board in Main Hallway**

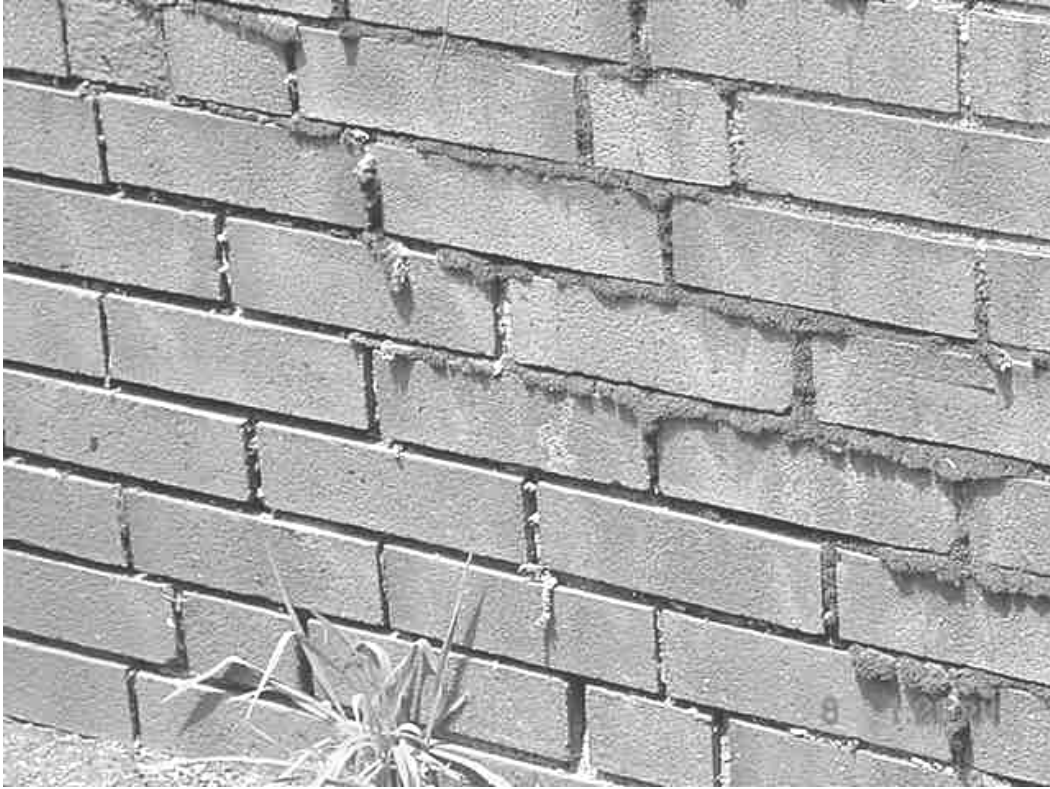
**Picture 12**

- The exterior walls had spaces/cracks in brickwork. In many areas mortar around exterior brickwork appears to be crumbling or missing (Picture 12). These conditions are breaches of the building envelope and provide a means for water entry into the building. Repeated water penetration can result in the chronic wetting of building materials and the potential for microbial growth. Areas with missing or crumbling mortar have sustained heavy moss growth. In addition, large wall cracks may provide a means of egress for pests/rodents into the building.
- The roof of the building is reported to have problems with drainage. No gutter/downspout system or any rooftop drains were present in or around the roof at

**Missing Damaged Mortar and Heavy Moss Growth between Bricks**

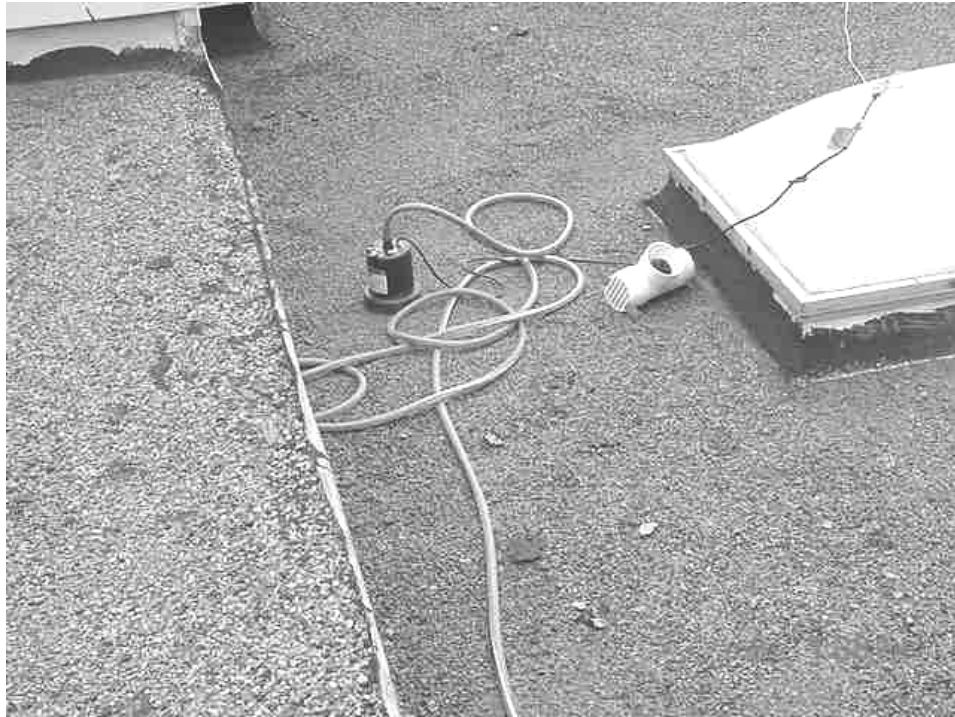
**Picture 13**

the time of assessment. Instead, a portable electric pump attached to a garden hose is stationed on the roof to help remove water (Picture 13). Normally buildings are equipped with roof drains and/or a gutter/downspout system to collect and drain water away from the building. Lack of proper drainage can allow rainwater to pool on the roof and at the base of the building against exterior walls.

**Portable Pump on Roof to Remove Water**

2. Examine the feasibility of enhancing drainage to areas of the roof subject to water pooling (e.g. east wing roof). Consider the installation of a gutter/downspout system or roof drains. This may include redirecting the pitch of the roof towards drains.

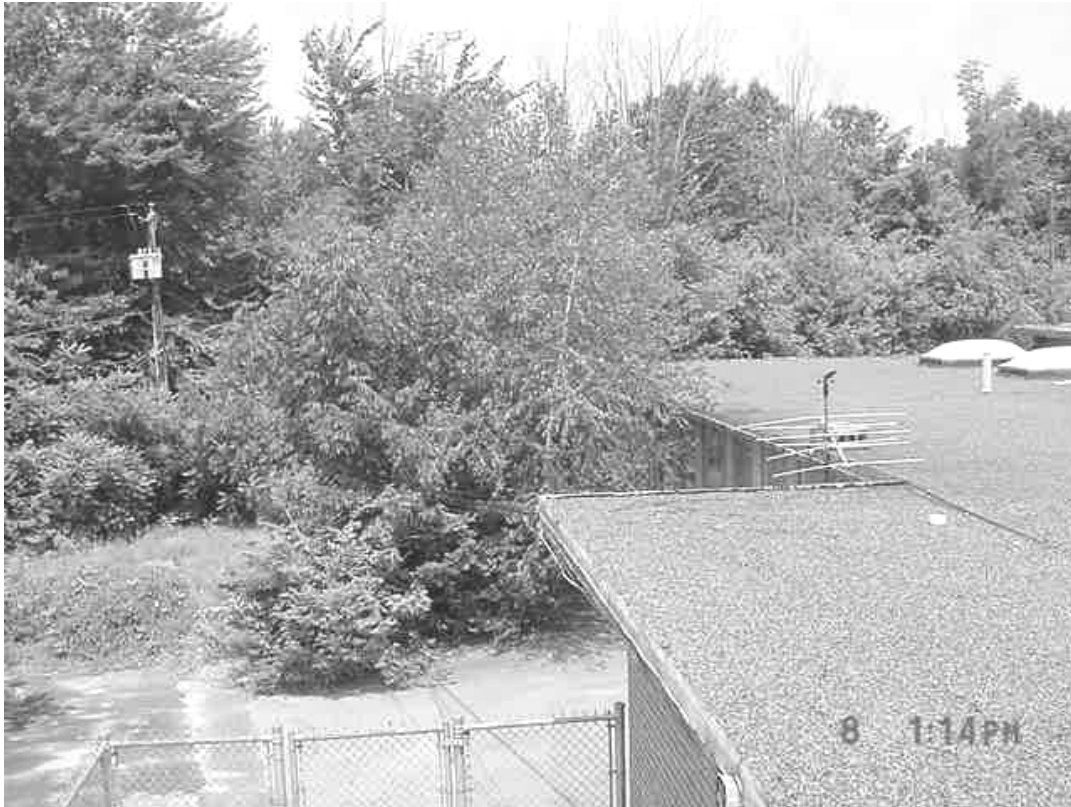
**Picture 14**

- Shrubbery/trees were in direct contact with the exterior wall brick in several areas around the building (Picture 14). Plants growing in close proximity to the building can serve as a possible source of water impingement to the exterior curtain wall. In addition, the growth of roots against the exterior walls can bring moisture in contact with wall brick and eventually lead to cracks and/or fissures in the foundation below ground level. Over time, this process can undermine the integrity of the building envelope and provide a means of water entry into the building through capillary action through foundation concrete and masonry (Lstiburek & Brennan, 2001).

**Trees/Shrubbery over Roof and in Direct Contact With the Building**

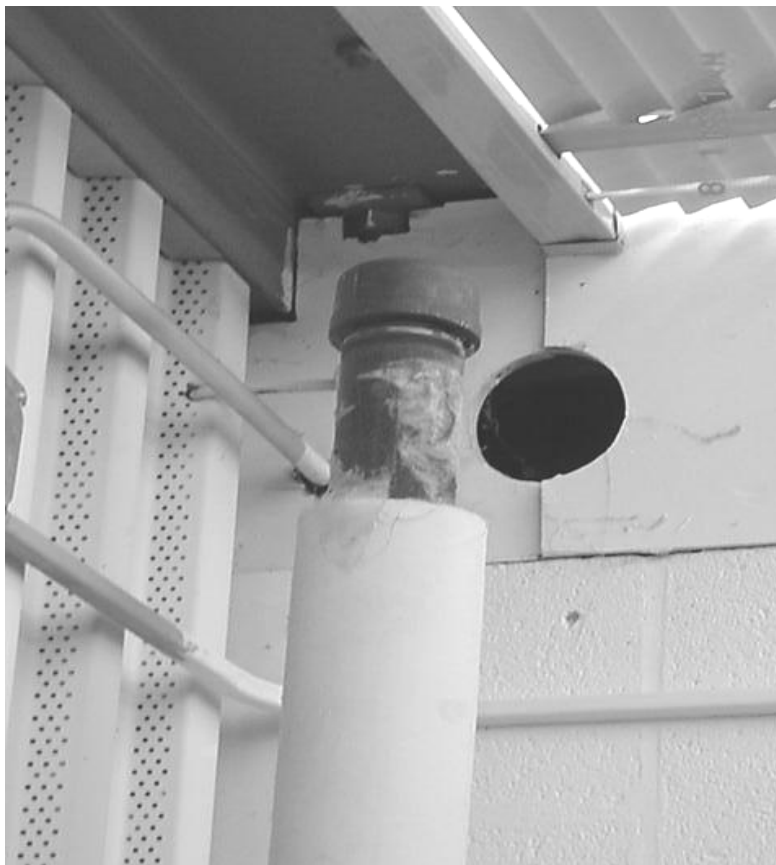
**Picture 15**

Open utility holes and wall spaces were noted in a number of areas (Pictures 15 & 16). These breaches can provide a pathway for the movement of drafts, odors and particulate matter between rooms and floors.

**Open Utility Hole**

9. Replace/repair broken windows to prevent water leaks and subsequent microbial growth.
10. Replace any missing ceiling tiles and fill utility holes, to prevent the migration of odors, dust and particulate matter between rooms.

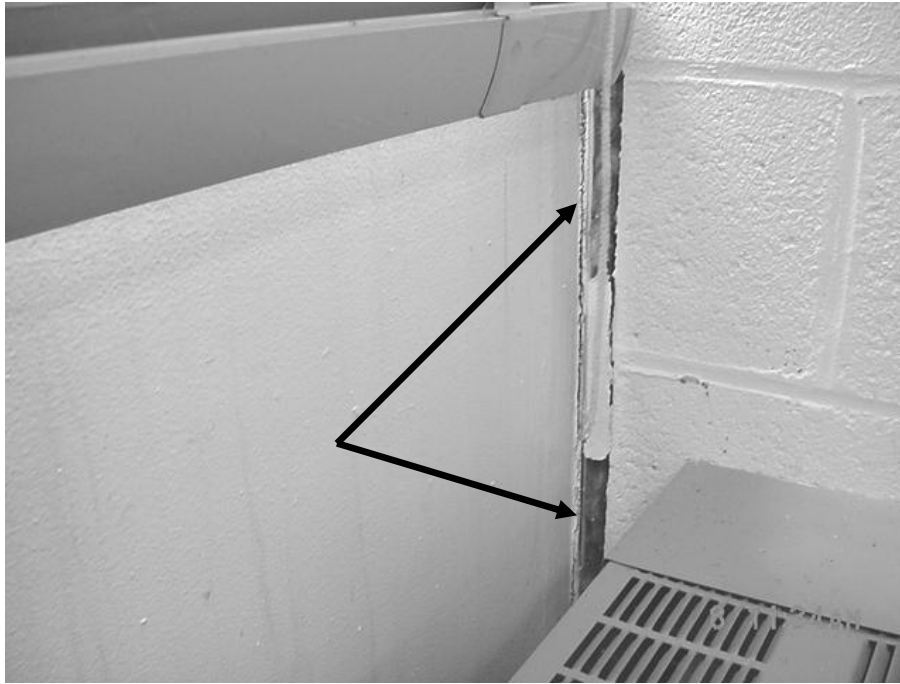
**Picture 16**

**Open Seam in Wall Junction**

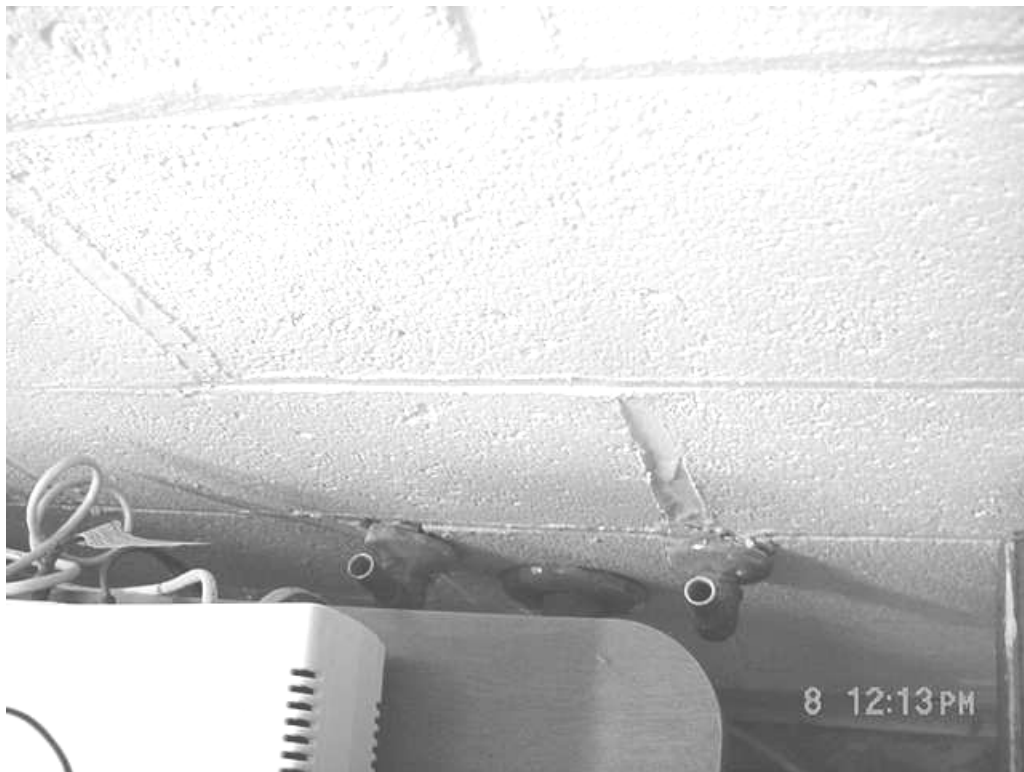
**Picture 17**

Unsealed plumbing pipes connected to a sink (Picture 17) were seen in the Town Clerk's office. Sink drains are usually designed with traps in order to prevent sewer odors/gases from penetrating into occupied spaces. When water enters a drain, the trap fills and forms a watertight seal. Without periodic input of water (e.g., every other day), traps can dry, preventing a watertight seal. Without traps, odors and other material can

travel up the drain and enter occupied spaces. Sewer gas can be irritating to the eyes, nose and throat of some individuals.

**Open Plumbing Pipes to Former Sink**

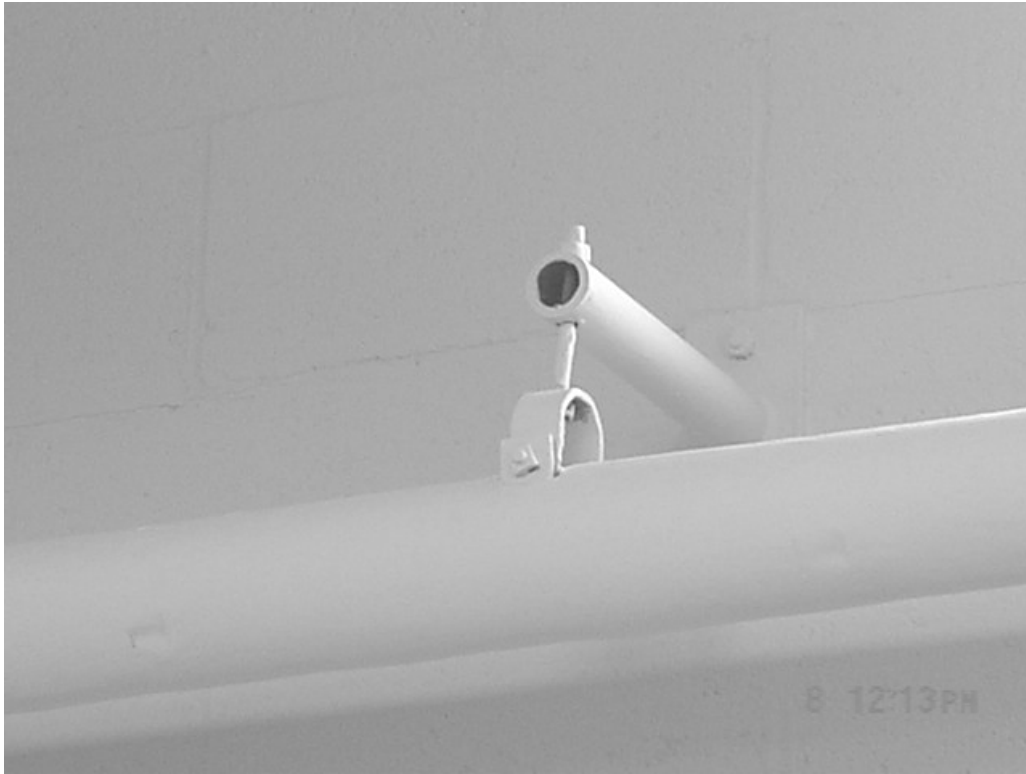
**Picture 18**

Occupants in the Town Clerk's Office reported infestation of hornets/wasps. Hornets/wasps were seen entering the space through an open utility pipe (Picture 18). Under current Massachusetts law that, effective November 1, 2001, the principles of integrated pest management (IPM) must be used to remove pests in state buildings and grounds (Mass Act, 2000). Although not a state office building, the principals of IPM can be used in any facility.

**Open Pipe in Town Clerk's Office Where Hornets/Wasps Were Seen**

15. Use of the principles of integrated pest management (IPM) to rid this building of pests is highly recommended. A copy of the IPM recommendations can be downloaded from the Internet at  
[http://www.state.ma.us/dfa/pesticides/publications/IPM\\_kit\\_for\\_bldg\\_mgrs.pdf](http://www.state.ma.us/dfa/pesticides/publications/IPM_kit_for_bldg_mgrs.pdf).
